**Implications of a comparison of geological and hydrological
conditions in the Akzo-Retsof, Morton-Himrod and Cargill
Cayuga salt mines, New York State**

Dr John K. Warren

SaltWork Consultants Pte Ltd (ACN 068 889 127)
Kingston Park, Adelaide, South Australia 5049

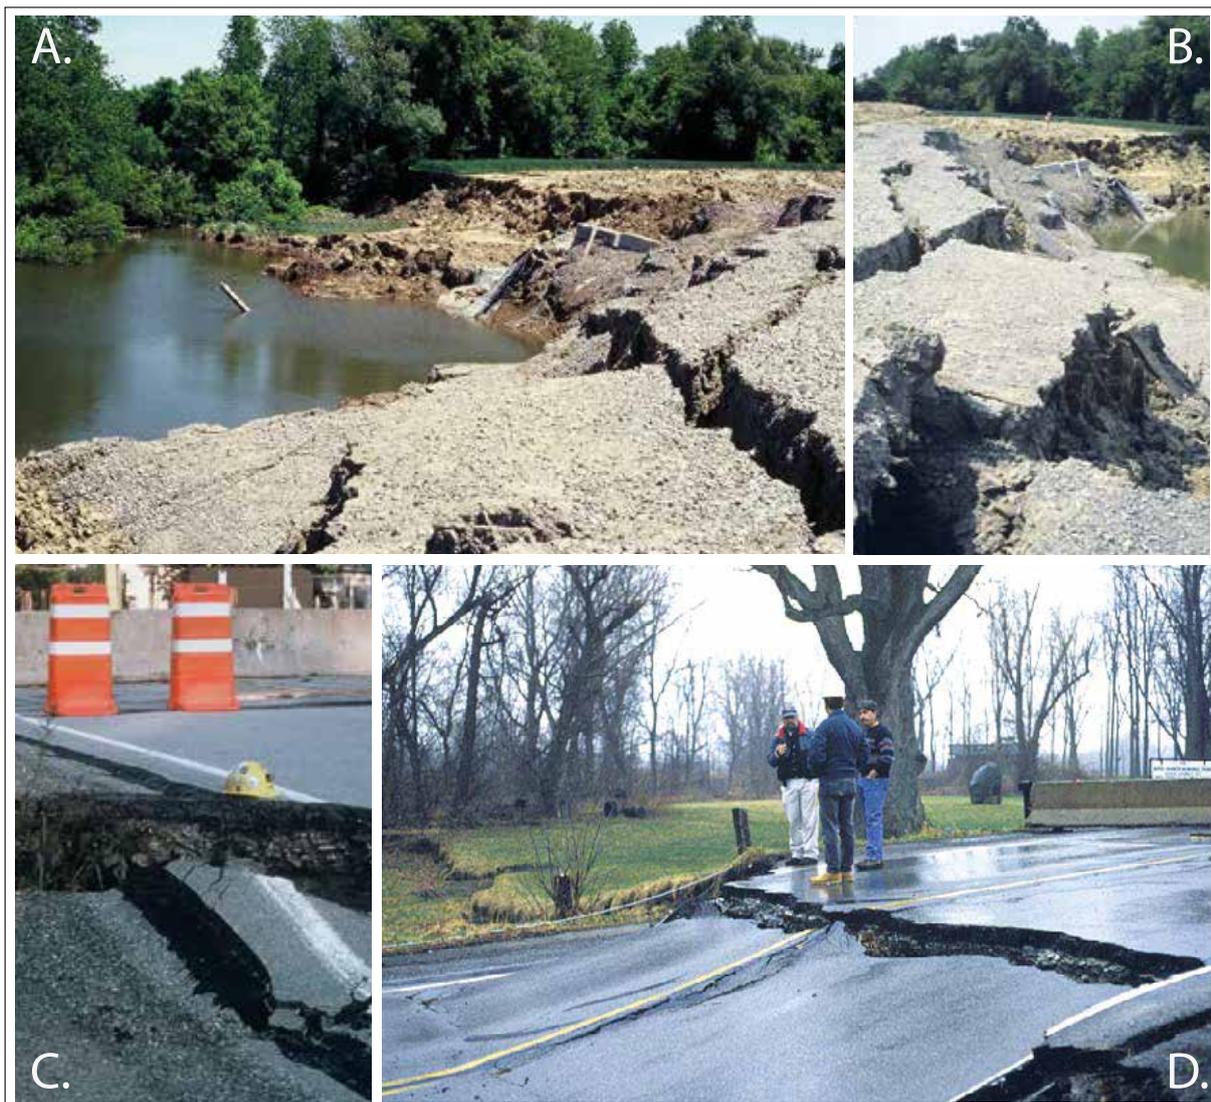
Figure 5. Surface effects related to Retsof Mine roof collapse. A and B) Partially water-filled solution collapse dolines above the region of yield pillars in the Retsof Salt Mine. C & D) Subsidence-related roadbed collapse on Route 20A (images downloaded from < <http://www.rcsiweb.org/gallery.html>> on Dec 6, 2016).

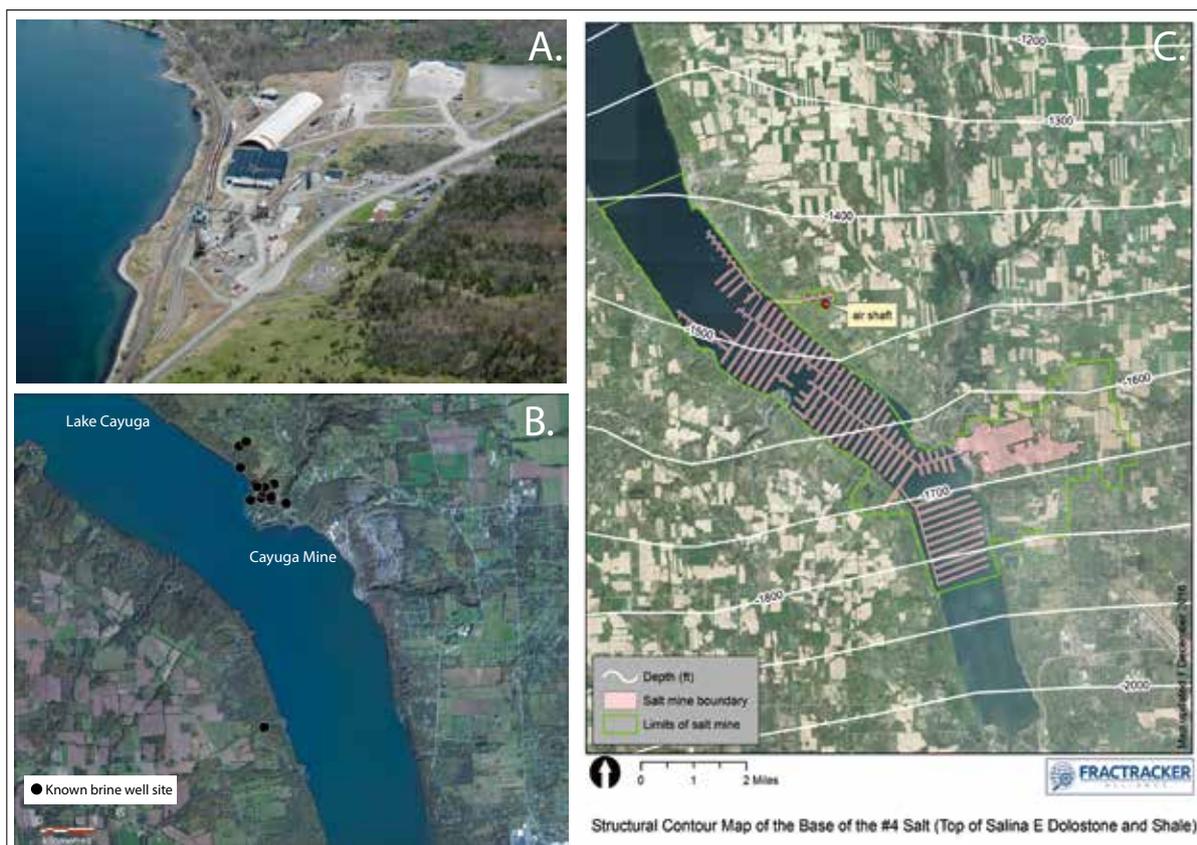
Figure 10. Cayuga Salt Mine, New York State. A) Current lake shore position of Cargill Salt's main shaft and surface operations. B) Positions of documented brine wells ranging in age from the 1890s until the 1970s and extending to depths of more than a kilometre. C) Approximate extent of current mine workings beneath Lake Cayuga and contour of base Salt #4; Image courtesy of FracTracker).
